# Sicurezza del Volo

Aeroclub dello Stretto - Scuola di volo

Briefing del 26 gennaio 2013

AF447 – Lesson learned?

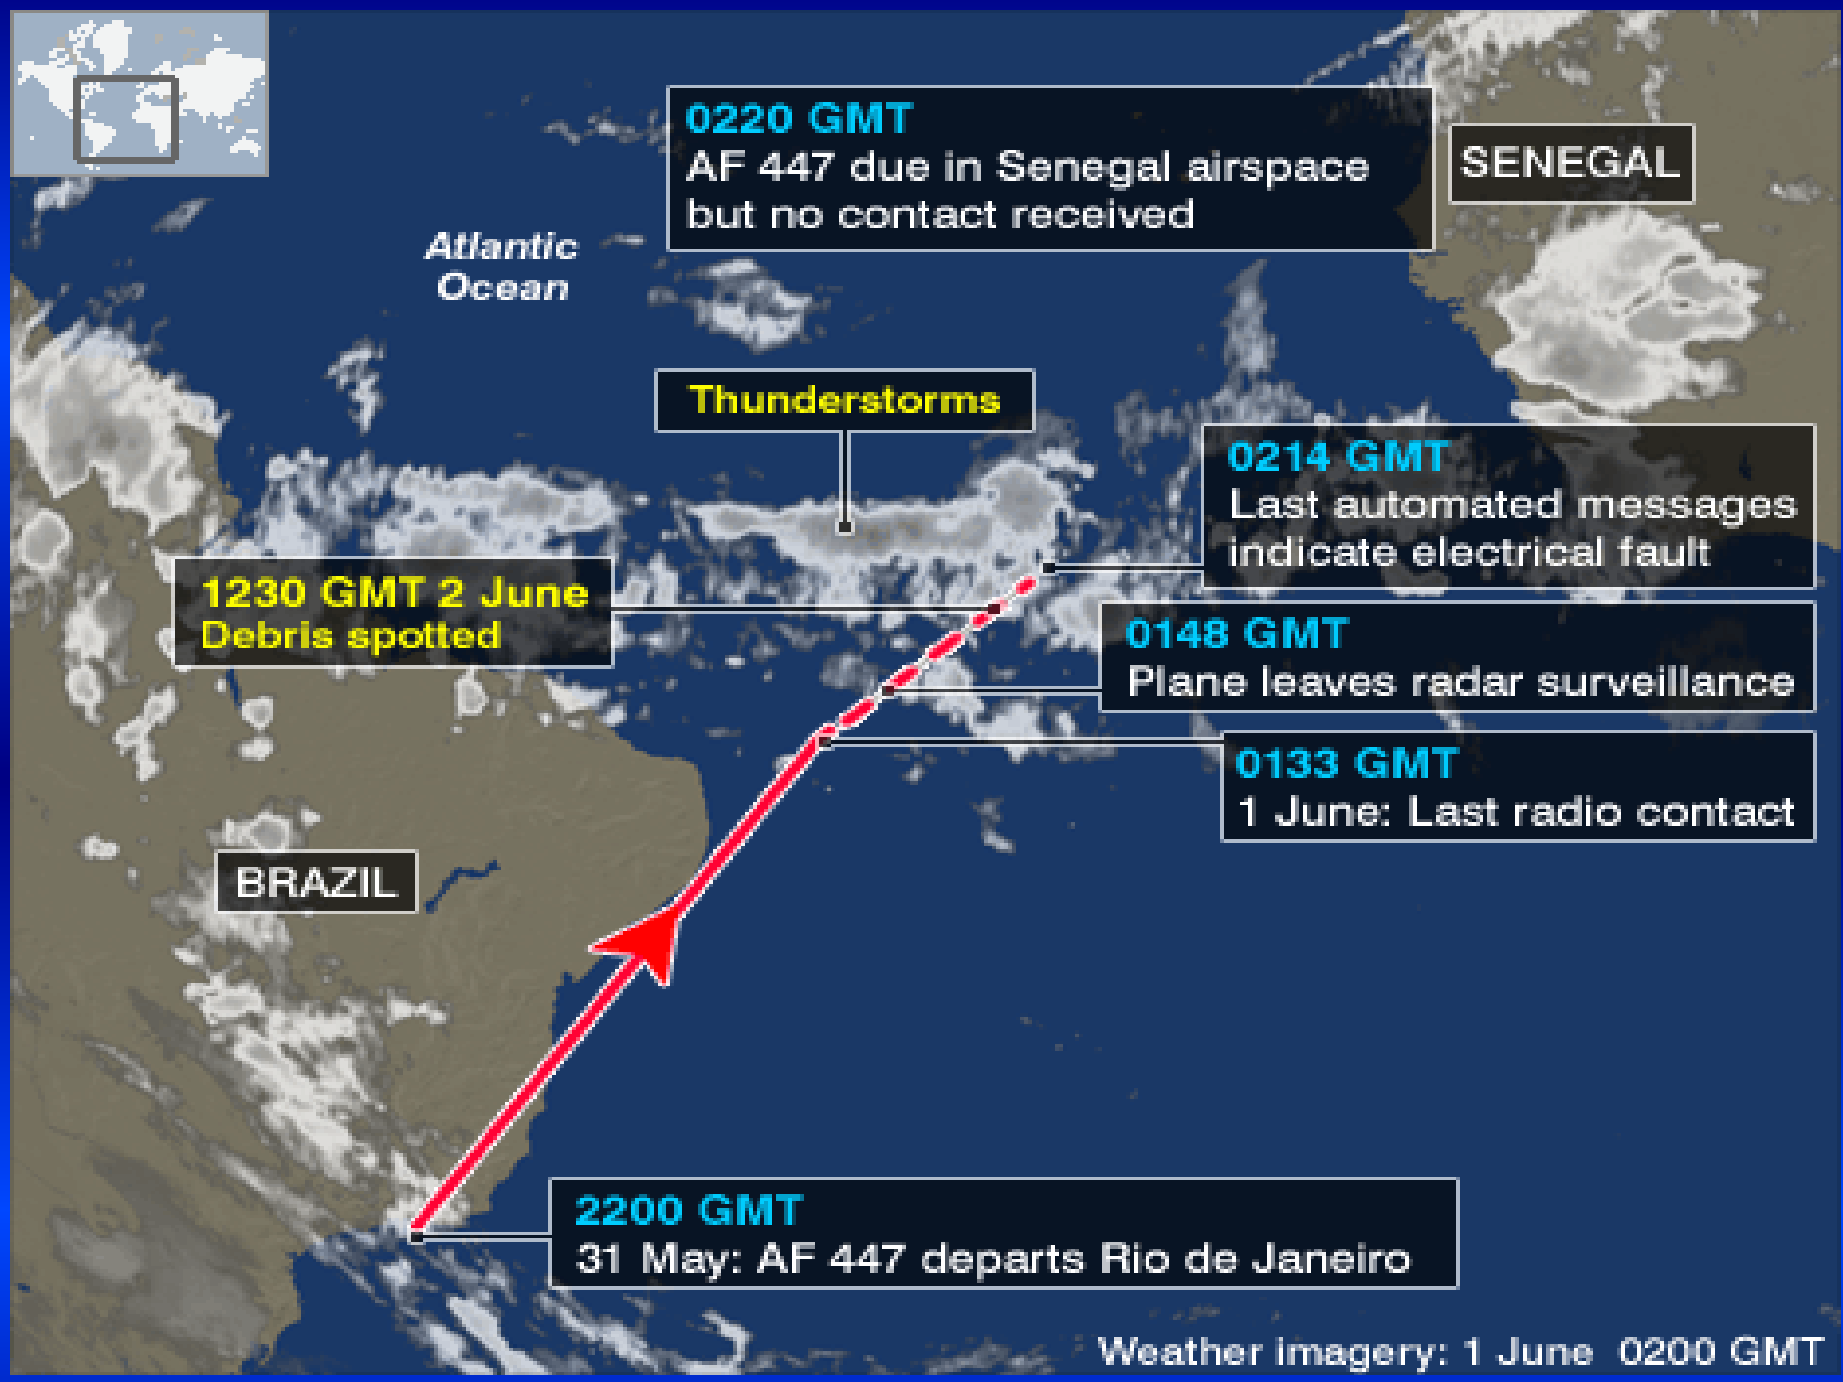
**0214 GMT**  
Last automated messages  
indicate electrical fault

**0148 GMT**  
Plane leaves radar surveillance

**0133 GMT**  
1 June: Last radio contact

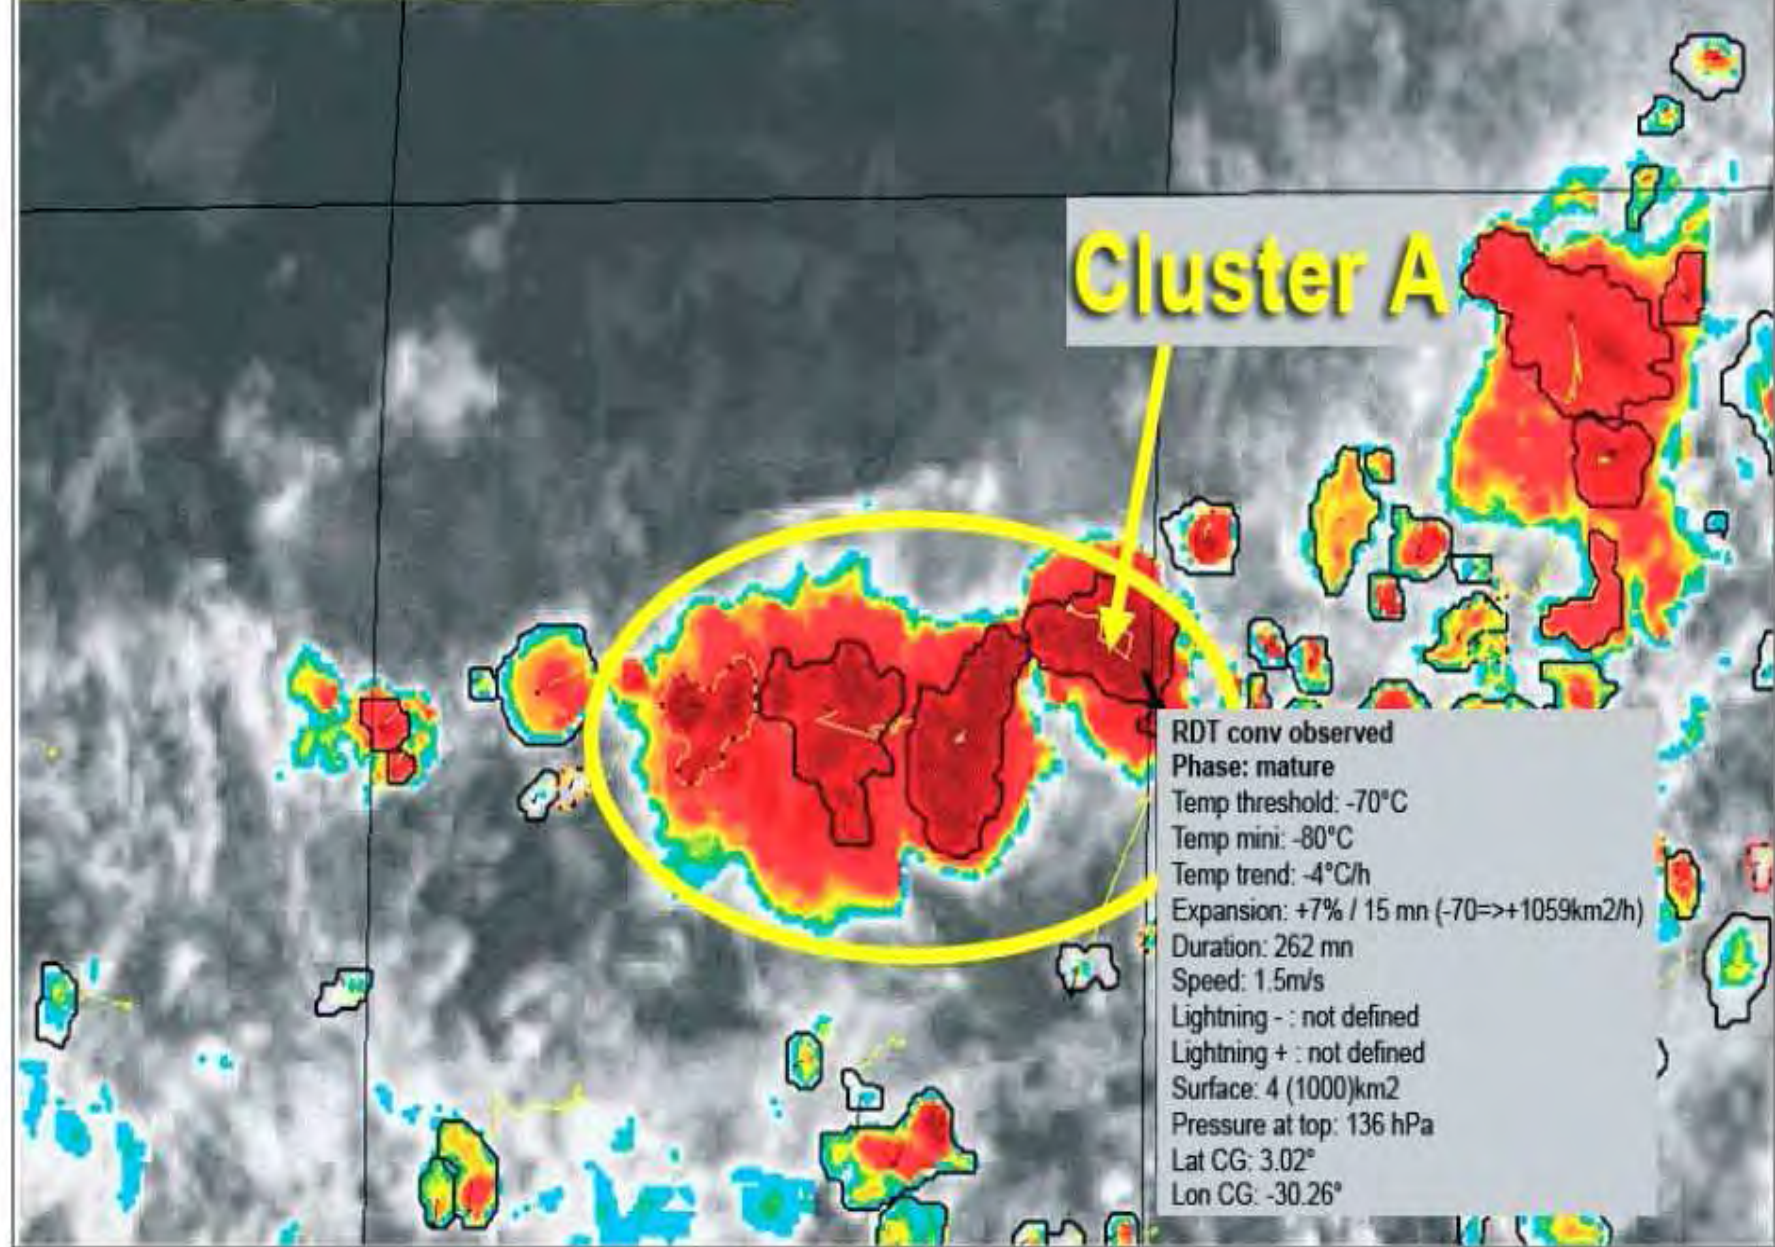
# Cluster A

RDT conv observed  
Phase: mature  
Temp threshold: -70°C  
Temp mini: -80°C  
Temp trend: -4°C/h  
Expansion: +7% / 15 mn (-70=>+1059km2/h)  
Duration: 262 mn  
Speed: 1.5m/s  
Lightning -: not defined  
Lightning +: not defined  
Surface: 4 (1000)km2  
Pressure at top: 136 hPa  
Lat CG: 3.02°  
Lon CG: -30.26°

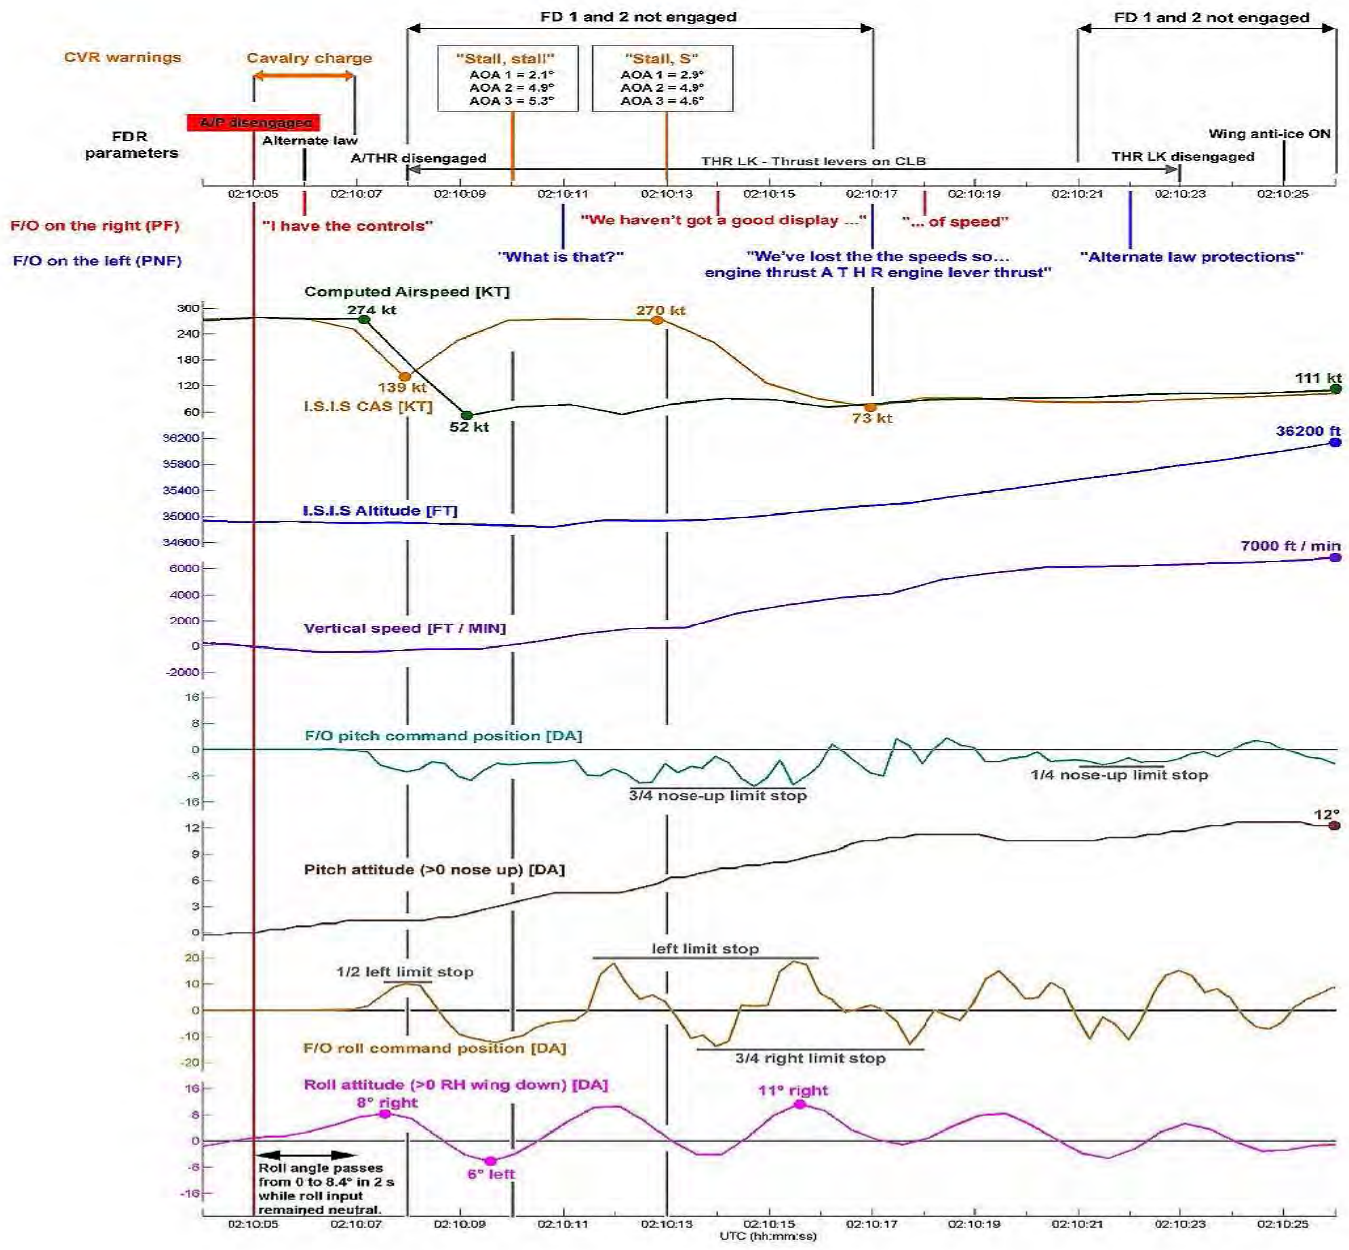
AF447  
Condizioni  
di volo

Parameters from 2 h 10 min 04 to 2 h 10 min 26

from  
02.10.04  
to  
02.10.26

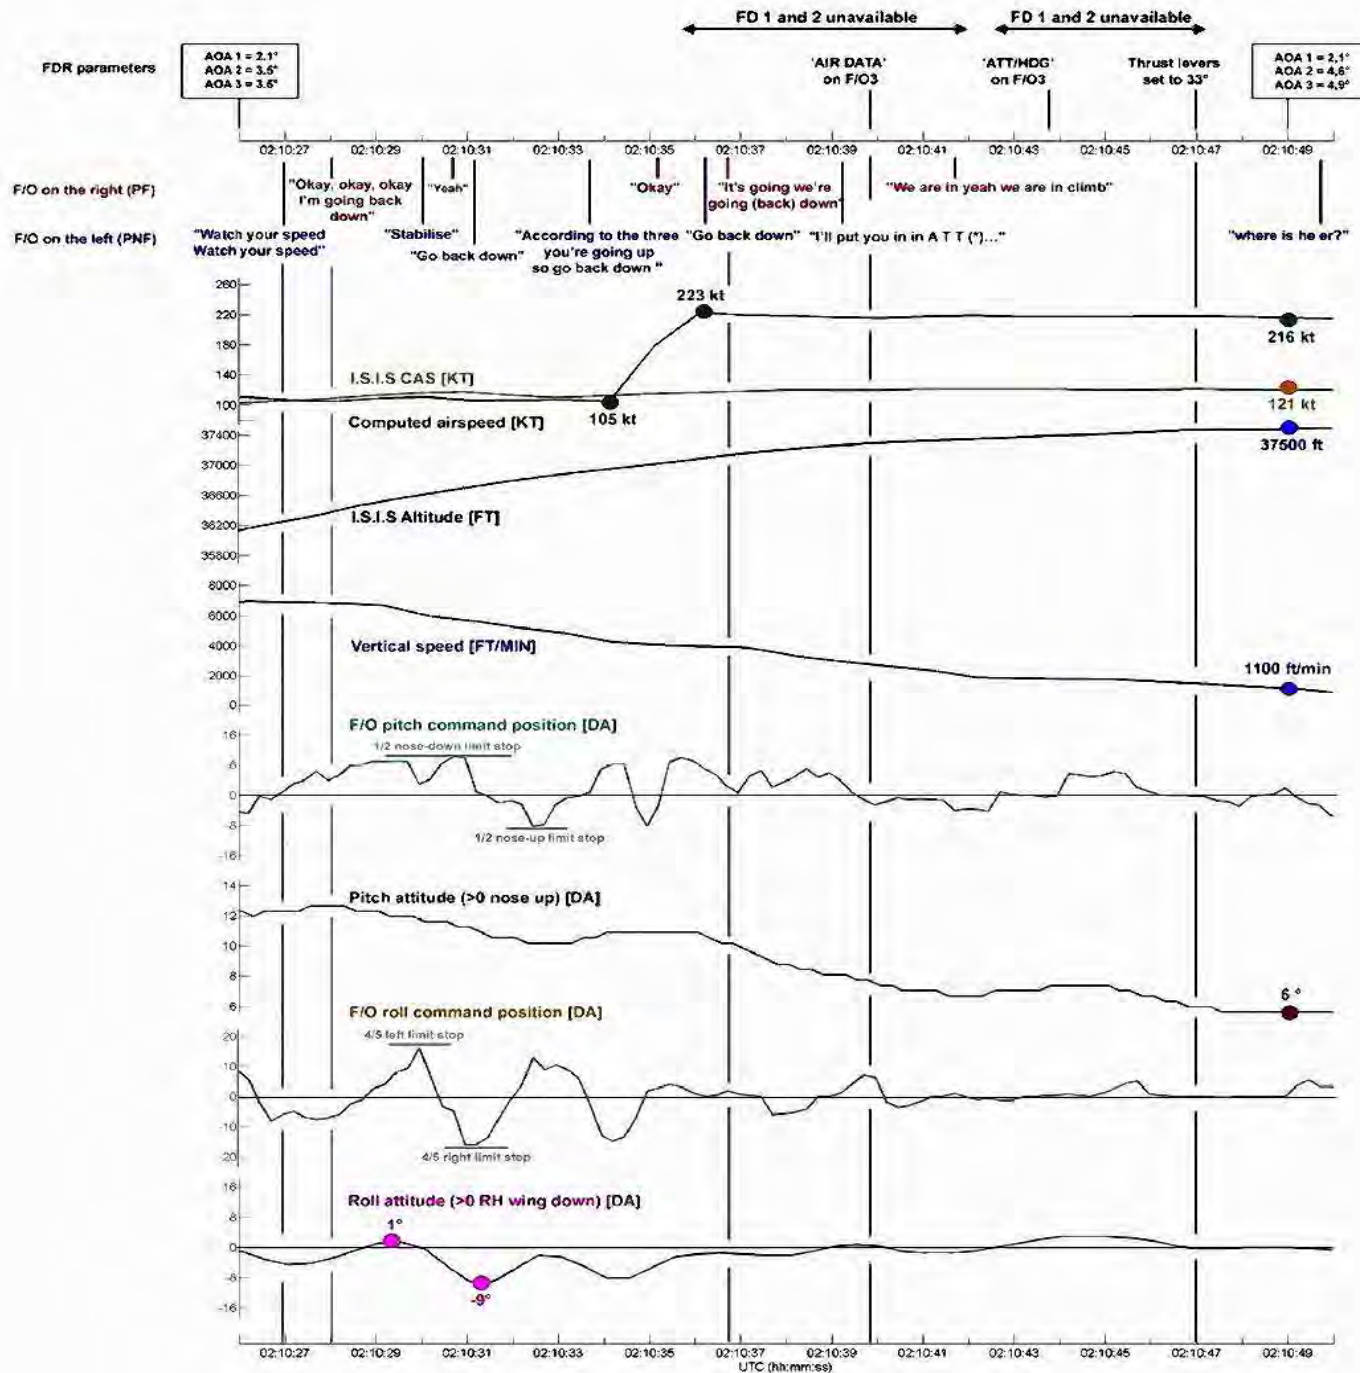
AF447  
Condizioni  
di volo

from  
02.10.27  
to  
02.10.49

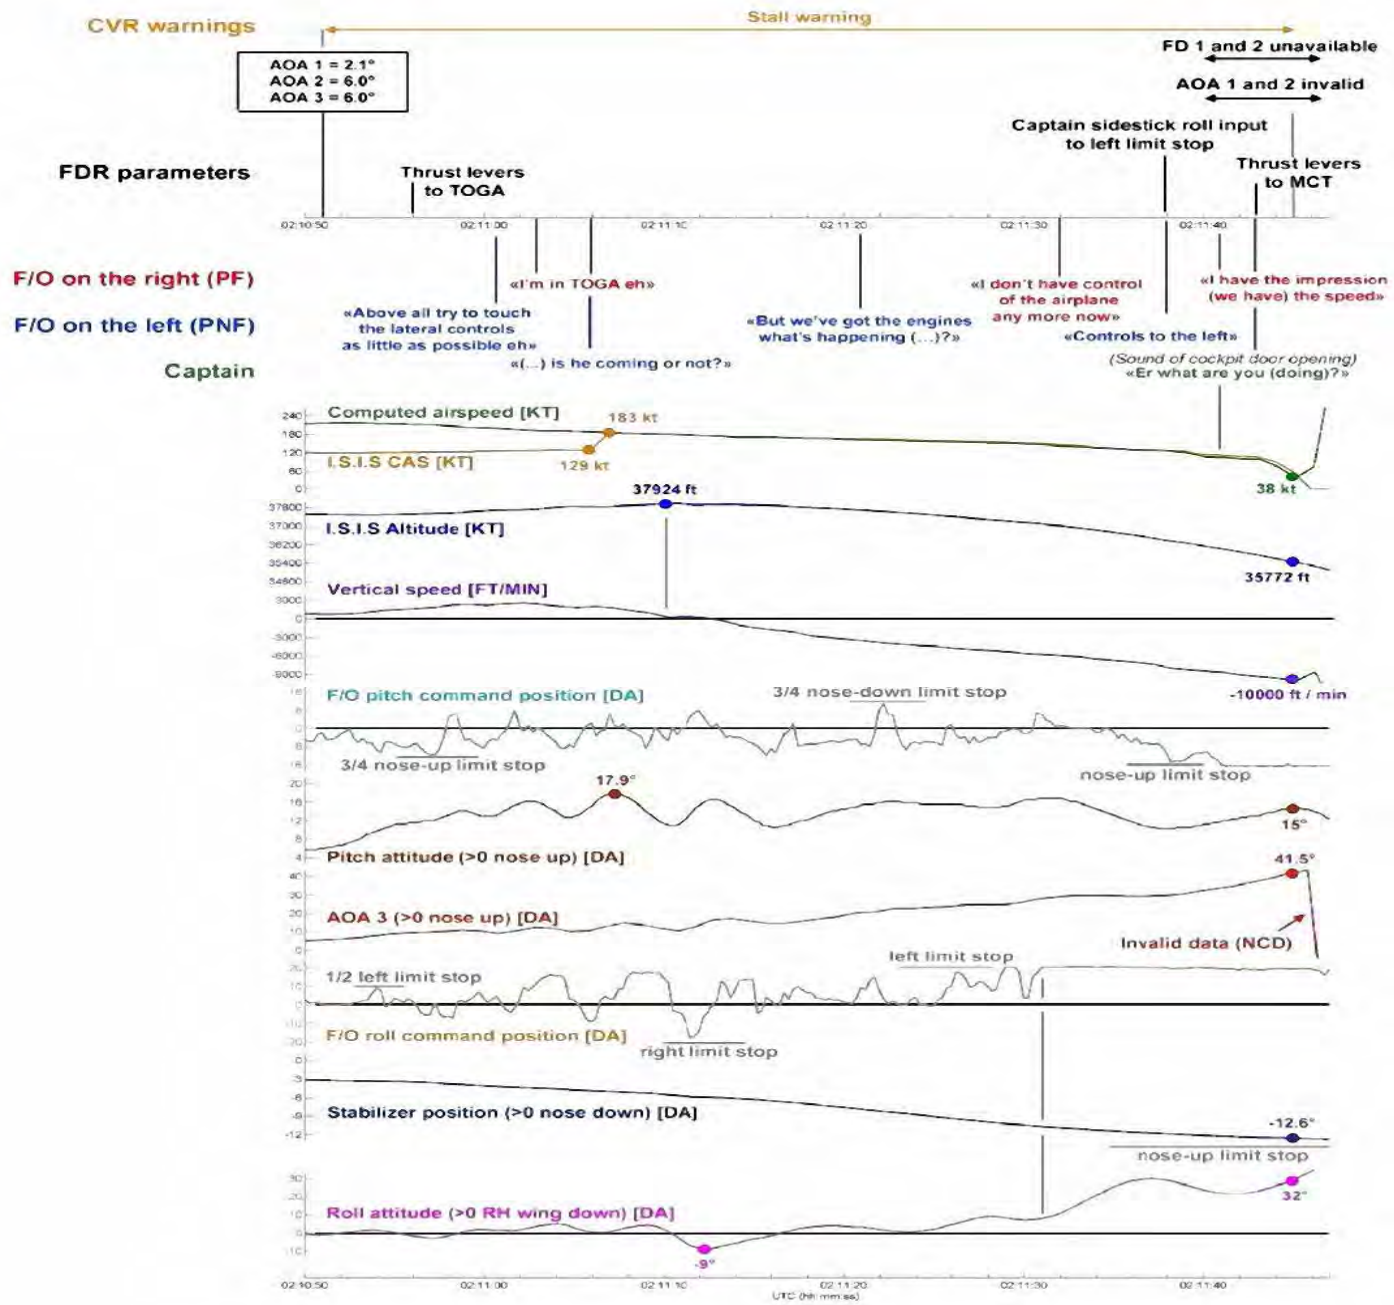
AF447  
 Condizioni di volo  
 from  
 02.10.50  
 to  
 02.11.46

Parameters from 2 h 10 min 50 to 2 h 11min 46

“At 02 h 10 min 51, when the aircraft was at about 37,500 ft and still climbing, the stall warning was activated. A change in the recorded normal acceleration behavior was revealed from 02h 10 min 53, at an angle of attack about 1 to 2 degrees greater than the warning activation threshold.”

“This modification of the behavior in the load factor at the centre of gravity results in the appearance of a high frequency component of an amplitude increasing to until about 0.1 g peak-to-peak, and with a signature that is very different from a turbulence signature of meteorological origin”.
