# Sicurezza del Volo

Aeroclub dello Stretto - Scuola di volo

Briefing del 26 gennaio 2013

AF447 – Lesson learned?

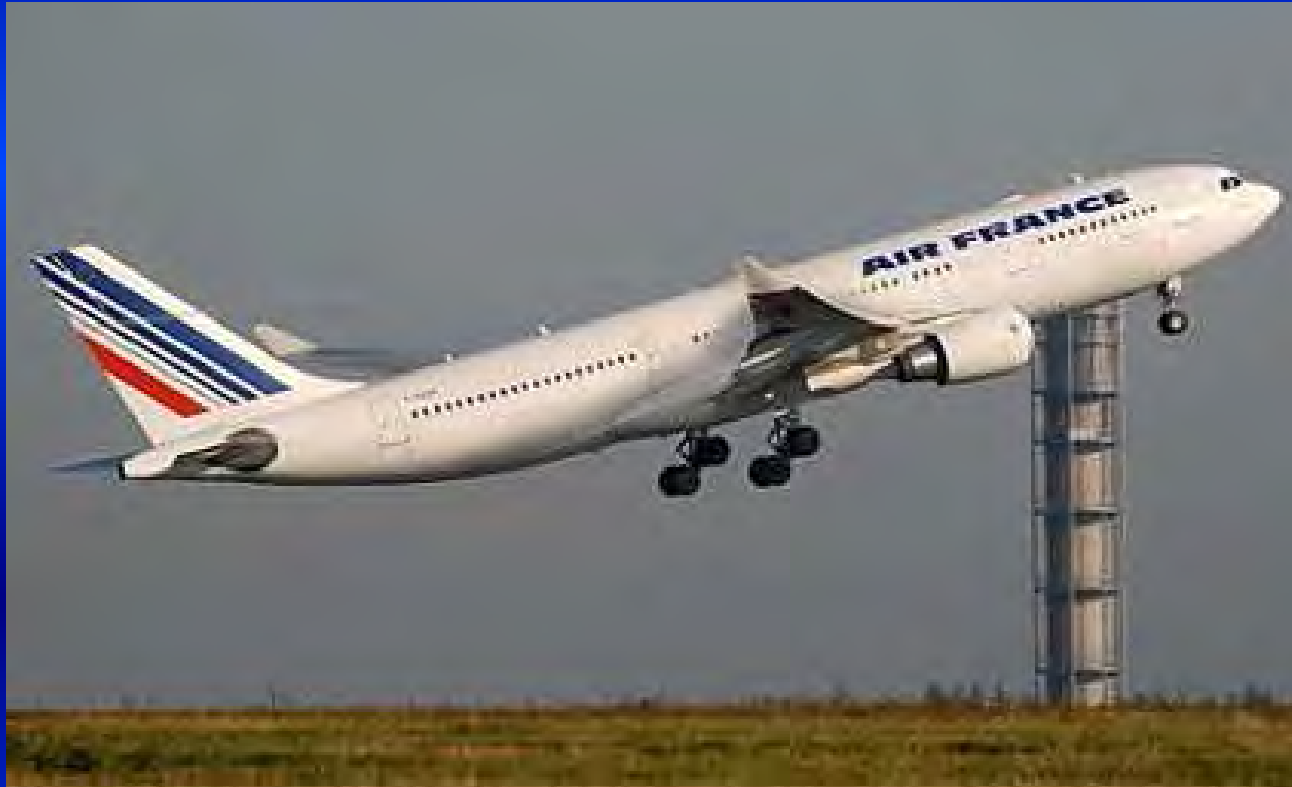
# Event Study: AF447

L'incidente si è verificato poco dopo le 02:00 h del 1 ° giugno 2009. Volo AF447, Rio de Janeiro- Paris C. de G., Airbus A330-203 marche F-GZCP con 12 membri dell'equipaggio e 216 passeggeri, durante la fase di crociera con turbolenza leggera a FL 350 (10.700 m) e Mach 0.82

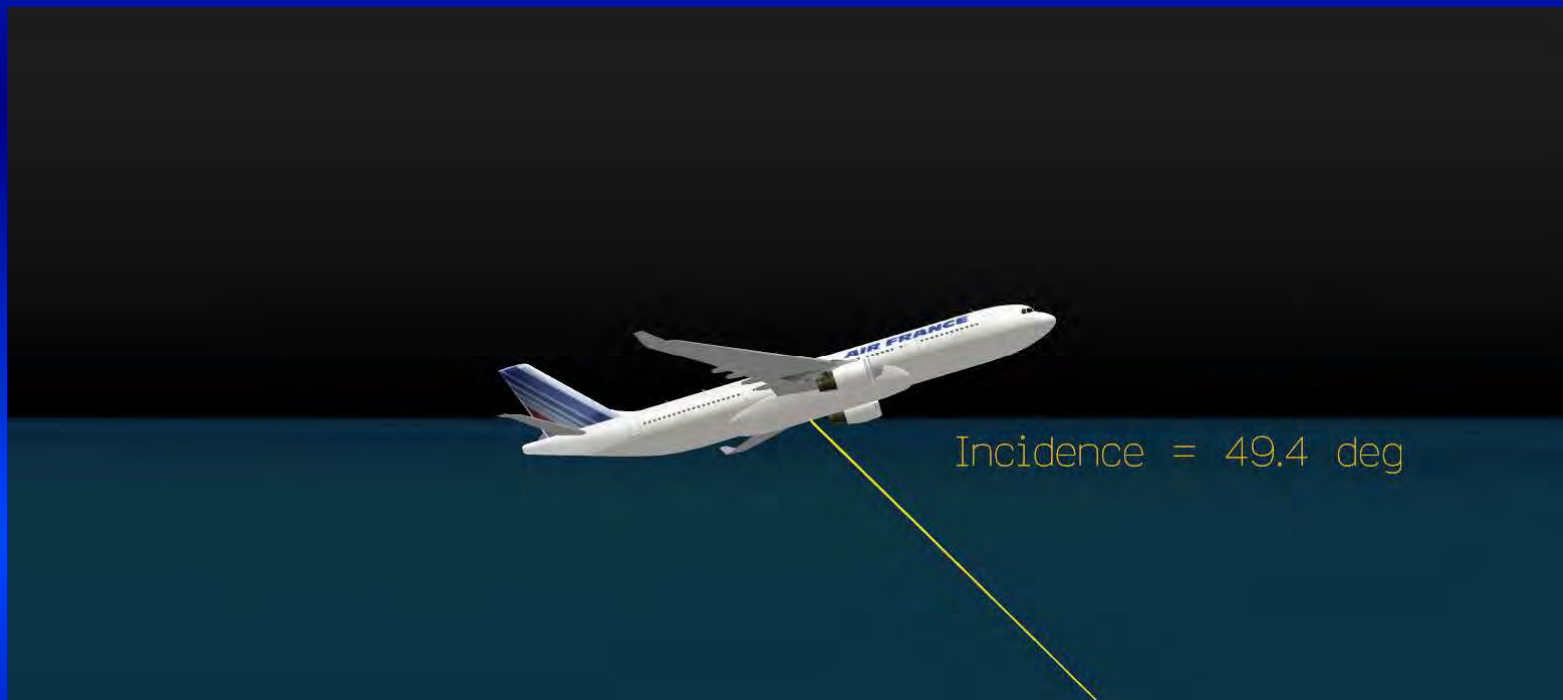
## From BEA Report: Initial investigation

- The airplane was intact at the moment of impact;
- It struck the surface of the water with a positive pitch-up attitude, slight bank and a high vertical speed;
- No preparation had been made for ditching;
- No depressurization had occurred;
- An inconsistency in the measured speeds had occurred shortly after time 02.10;
- This inconsistency had led to the loss of some automated systems;
- The accident had occurred between time 02 .14.26 and 02 .15.14
